## How to upgrade LiftNet central unit if Service Tool cannot detect firmware version

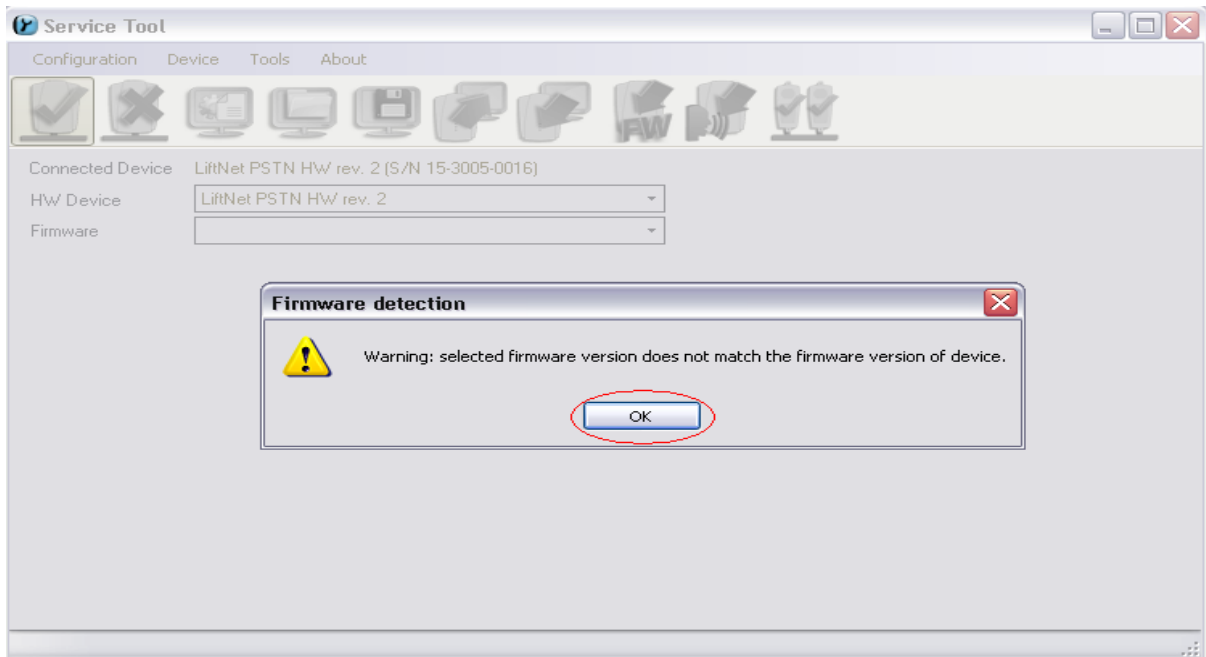
Pic. 3

2. Now you will get a warning: Selected firmware version does not match the firmware version of device (Pic. 3).

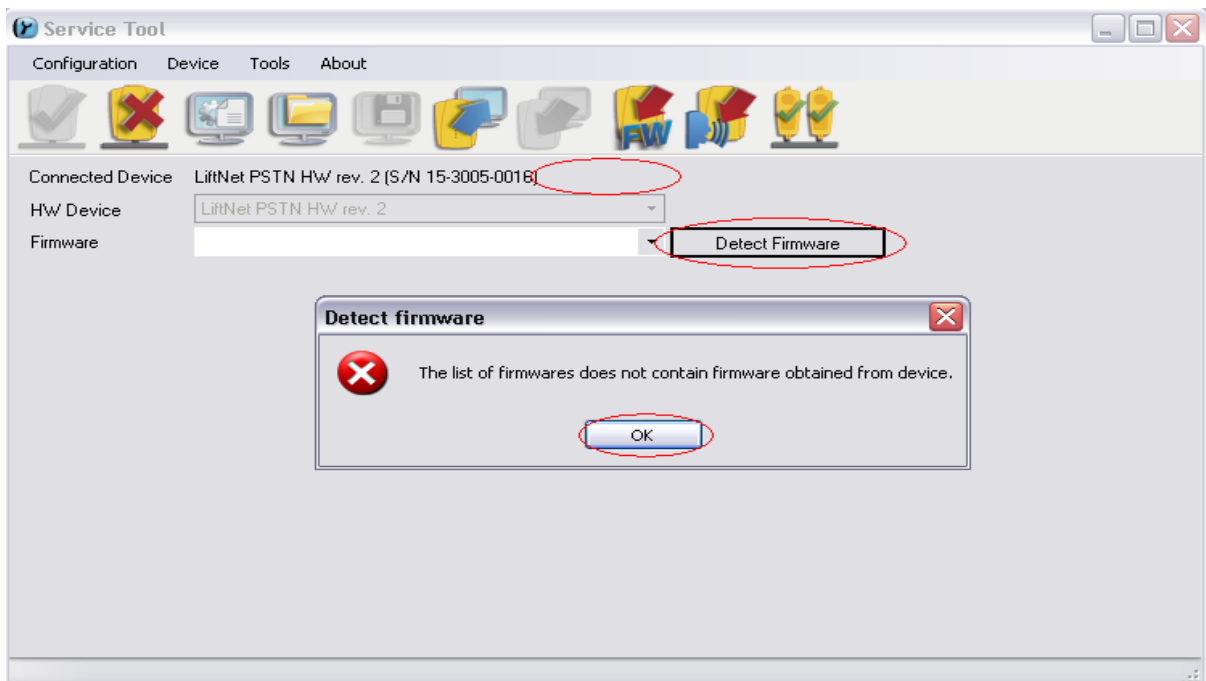
Pic. 4

3. On (Pic. 4) you can see that "Service Tool" did not detected actual firmware placed in LiftNet central unit.
